TOWN OF TORBAY FLOOD ANALYSIS GULLY

<u>APPENDIX 'D'</u> INSPECTION REPORT – EXISTING INFRASTRUCTURE

TORBAY STORMWATER MANAGEMENT PLAN

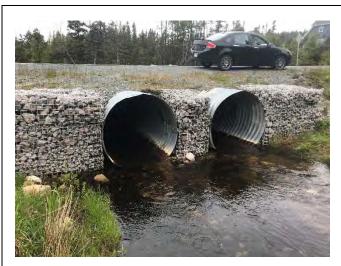
Twin 1500mm CSP - Rattling Brook Road

Date Surveyed	June 21, 2018
Location	Rattling Brook Road
End Treatment	None
Diameter (mm)	Twin 1500
Length(m)	18
Material	CSP
Condition	Culverts and gabion baskets in good condition
Invert In	81.767, 81.678
Invert Out	81.521, 81.460

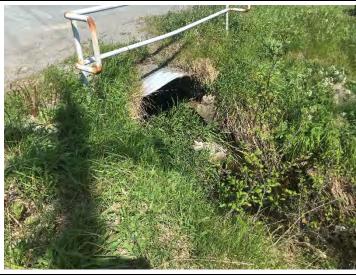
900mm CSP – Hickey's Place

Date Surveyed	June 21, 2018	
Location	Hickey's Place	
End Treatment	Concrete headwall	
Diameter (mm)	900	
Length(m)	30	
Material	CSP	
Condition	Concrete headwall experiencing minor concrete deterioration. Culvert slightly compressed	
Invert In	60.955	
Invert Out	60.170

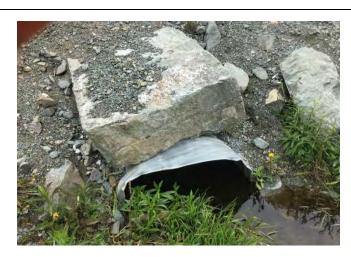
900mm CSP - Rosebud Street

Date Surveyed	June 21, 2018
Location	Rosebud Street
End Treatment	Circular
Diameter (mm)	900
Length(m)	12
Material	CSP
Condition	Large rock compressing inlet side of culvert. Outlet side of culvert in good condition
Invert In	87.724
Invert Out	87.866

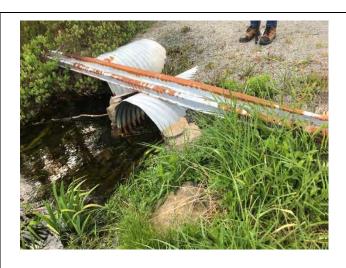
Twin 900 CSP - Woodfine's Place

Date Surveyed	June 21, 2018
Location	Woodfine's Place
End Treatment	Circular
Diameter (mm)	Twin 900
Length(m)	12
Material	CSP
Condition	Culverts in good condition
Invert In	117.483, 117.506
Invert Out	117.269, 117.305

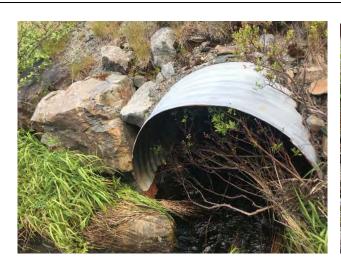
1200mm CSP - Bauline Line

Date Surveyed	June 21, 2018
Location	395 Bauline Line
End Treatment	None
Diameter (mm)	1200
Length(m)	14
Material	CSP
Condition	Culvert in good condition
Invert In	110.675
Invert Out	110.624

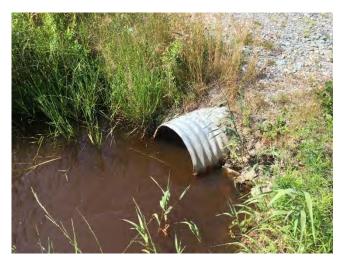
400mm CSP – Bauline Line

Date Surveyed	August 13, 2018	
Location	Bauline Line	
End Treatment None		
Diameter (mm)	400	
Length(m)		
Material	CSP	
Condition	Culvert in poor condition. Excessive standing water and bottom half of culvert appears to be rusted out.	
Invert In	88.625	
Invert Out	82.547

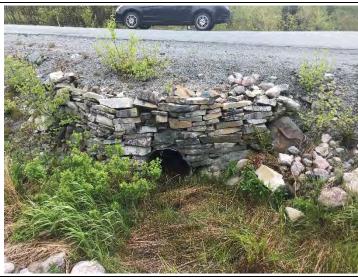
<u>500mm CSP – Victoria Place</u>

Date Surveyed	August 13, 2018	
Location	Victoria Place	
End Treatment	Brick	
Diameter (mm)	500	
Length(m)	12	
Material	CSP	
Condition	Brick end treatment appears to be deteriorating. The culvert is slightly compressed	
Invert In	113.225	
Invert Out	113.192
